Load-Deflection for Epoxy Repaired High Strength Reinforced Concrete Beams

Asst. Lect. Jawdat M. Kamal Tashan

Civil Engineering Department, College of Engineering

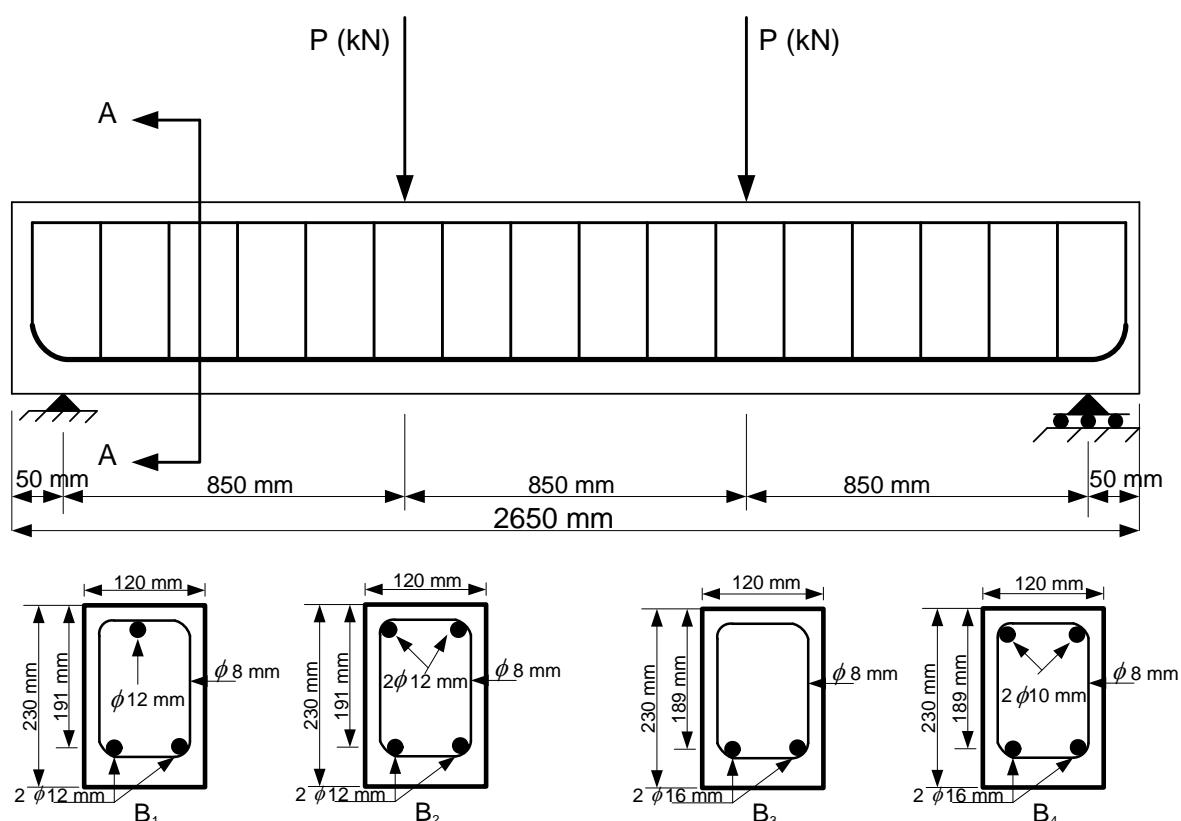
Figure (1) Details of test specimens

Beams reinforcement of (B₁ and B₂) consisted of two (12mm) diameter rebars, reinforcement of (B₃ and B₄) consisted of two (16mm) diameter rebars, while compressive reinforcement varied for all beams. The shear reinforcement for all beams consisted of single stirrups of (8mm) diameter at (100mm) center to center throughout the span of the beam. Details of the test specimens are shown in **Fig.(1)**.

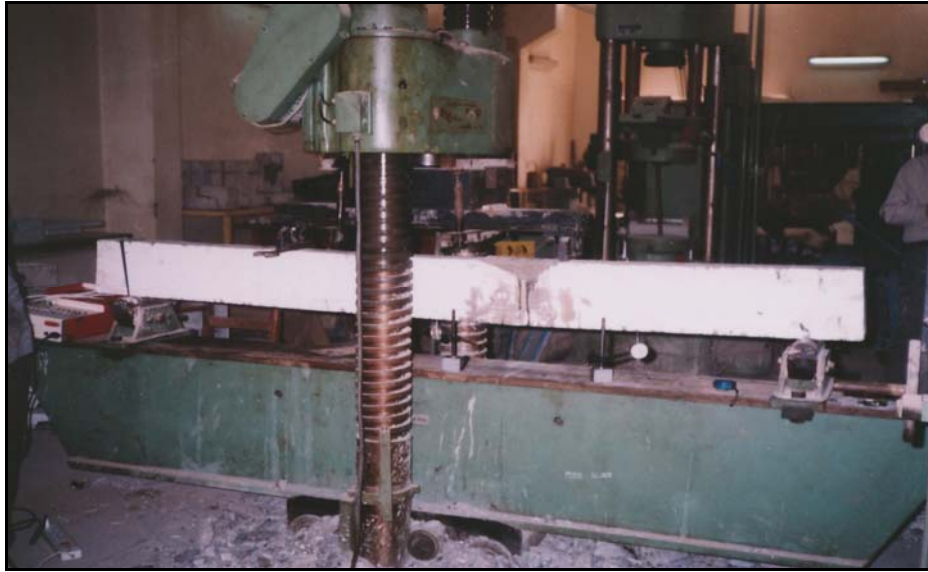
Plate (1) Loading for the test

The beam under test was simply supported over a span of (2550mm). Two equal point loads were applied to the third-points of the beam by a pair of hydraulic jacks. First third, second third from the support and mid-span deflections of the beam were measured with dial gauges. The load is applied in small increments and the dial gage readings are taken every 4kN until failure occurs. After each increment of loading, the deflections were recorded and the propagation of cracks was examined, detected and their widths are recorded at several levels of loading. **Plate (1)** shows the loading arrangement used throughout the tests.

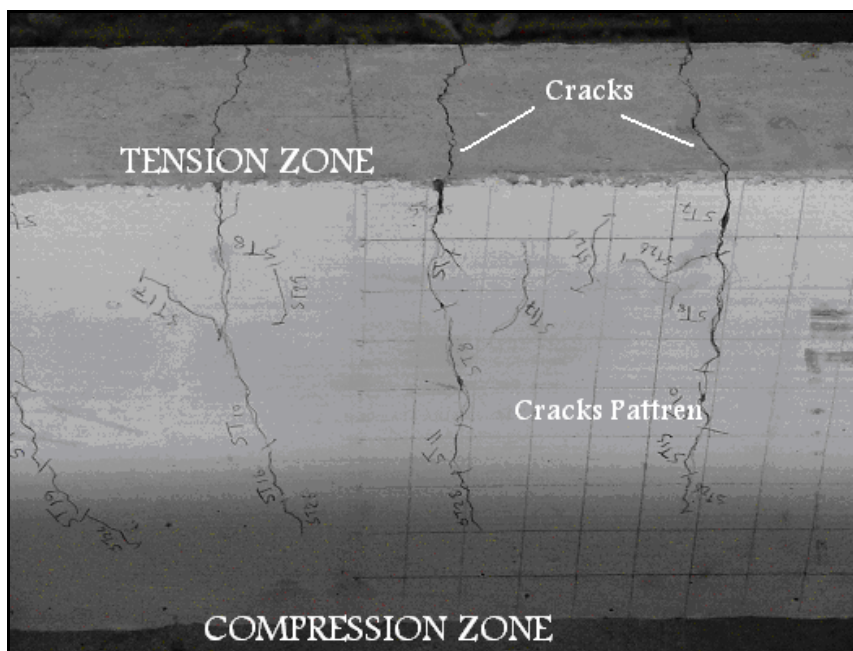
Plate (2) Set-up of epoxy injection [cleaning the cracks]

1. After flexural failure, the cracks and their neighboring areas are cleaned from dust, debris and other contaminants by applying compressed air using electrical blower to ensure good penetration of the resin and proper bond of the crack paste.

similar manner. The repaired beams were left at ambient temperature for one day and then tested to failure as before. **Plates (2), (3) and (4)** show that test procedure of beams and epoxy injection respectively.

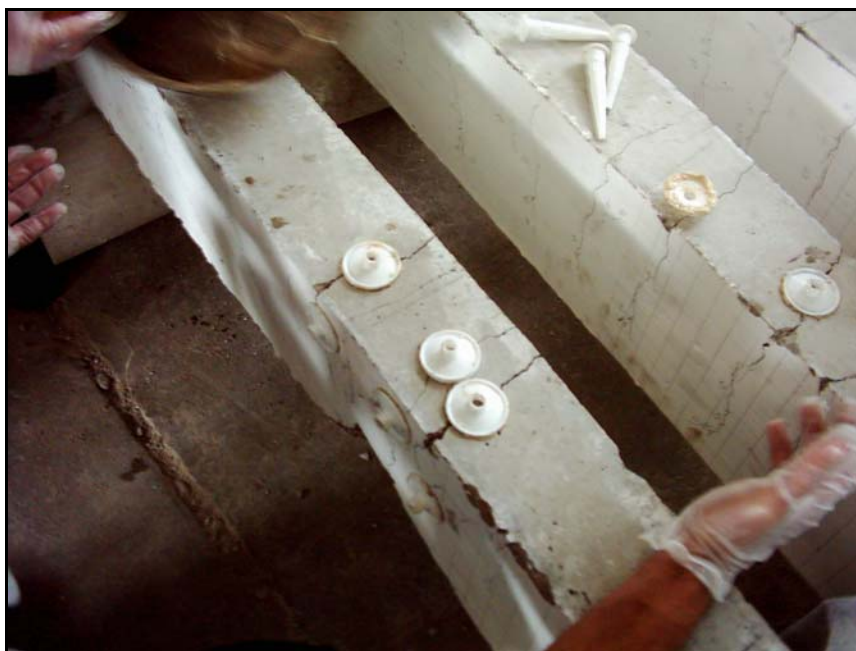
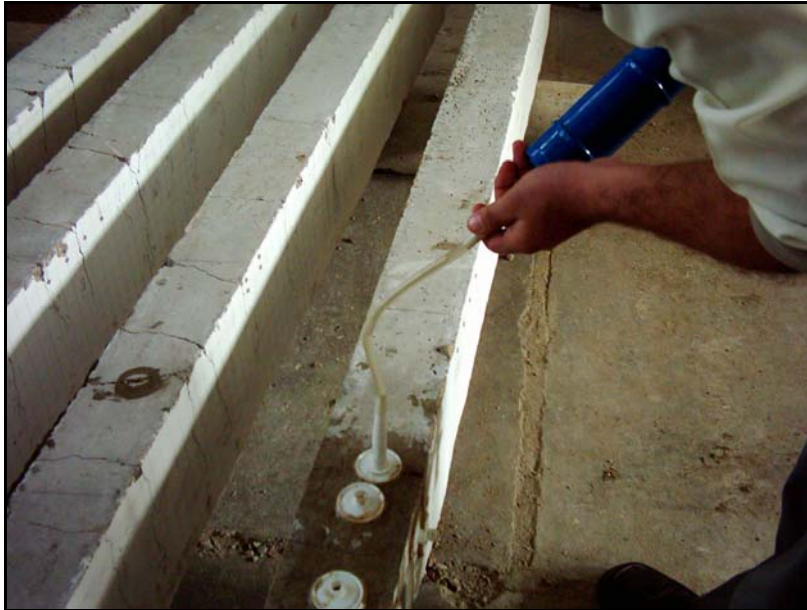
Plate (3) Epoxy injection for beams

2. Surface ports are then fixed along the considered crack. The port has an opening at the top for the epoxy to enter and a flange at the bottom bonded to the concrete. The ports are placed 10-15cm apart. The port is fixed in its proper position by applying an epoxy paste to the flange portion of the port taking care not to cover the hole, and then tacking it in place.

3. Epoxy paste is then used to seal over the surface ports and the exposed cracks. The paste is extended 20-30mm on either side of the crack with 2-3mm thickness to prevent resin seepage. The beam is then left for 30-45 minutes to ensure complete curing of the paste.

4. The two components of epoxy resin are then mixed in a metal batch using a mechanical stirrer at a proportion of 1(base): 3(hardener) by volume, according to the manufacturer's instructions.

5. A mechanical injection gun is fed with the mixed epoxy and the injection process started. The injection process began by pumping epoxy into the lowest port until the epoxy began to flow from the port above it. The first port was then plugged with a cap, and the process was repeated until the crack has been completely filled and all ports have been capped. Low pressure was used in injecting epoxy into the cracks. A curing period of about 24 hours was provided to the injected epoxy ^[2].

6. After the injected epoxy has cured, the ports were removed by striking with a hammer and the surface seal was chipped. Only the major cracks were treated in this way. The minor cracks, being less than (0.05mm) were too fine for complete penetration of the structural epoxy ^[3]. The crushed concrete in the compression zone of the beam was repaired in a

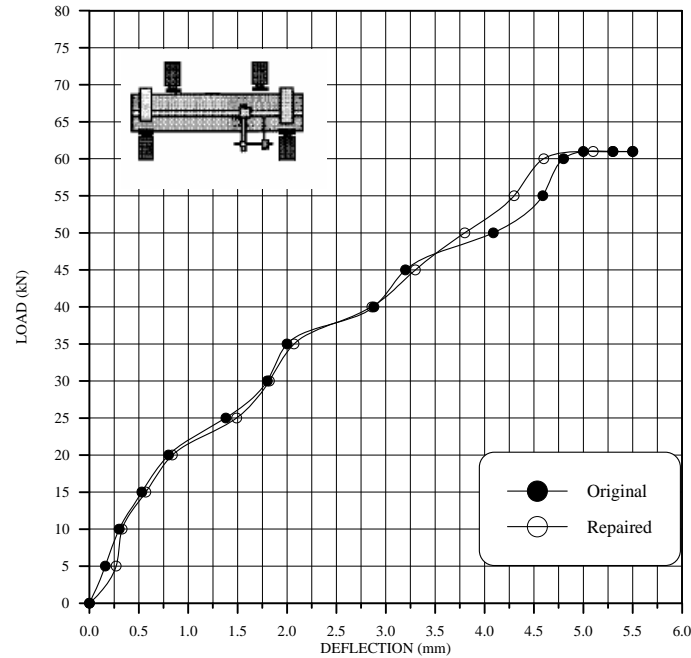
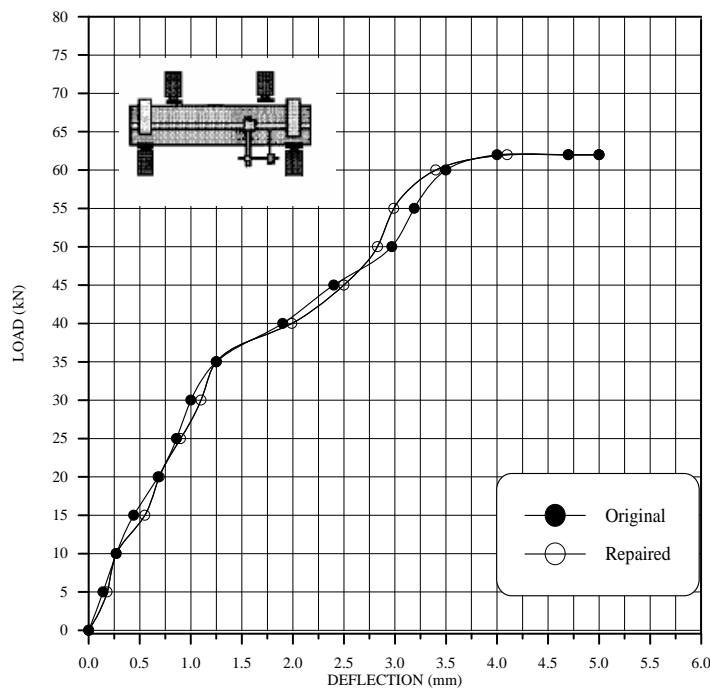
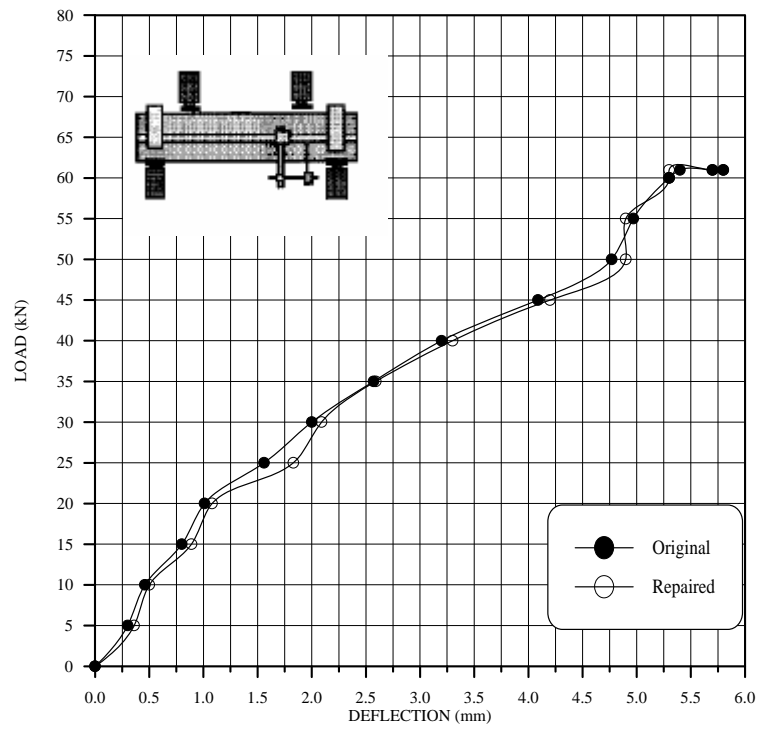
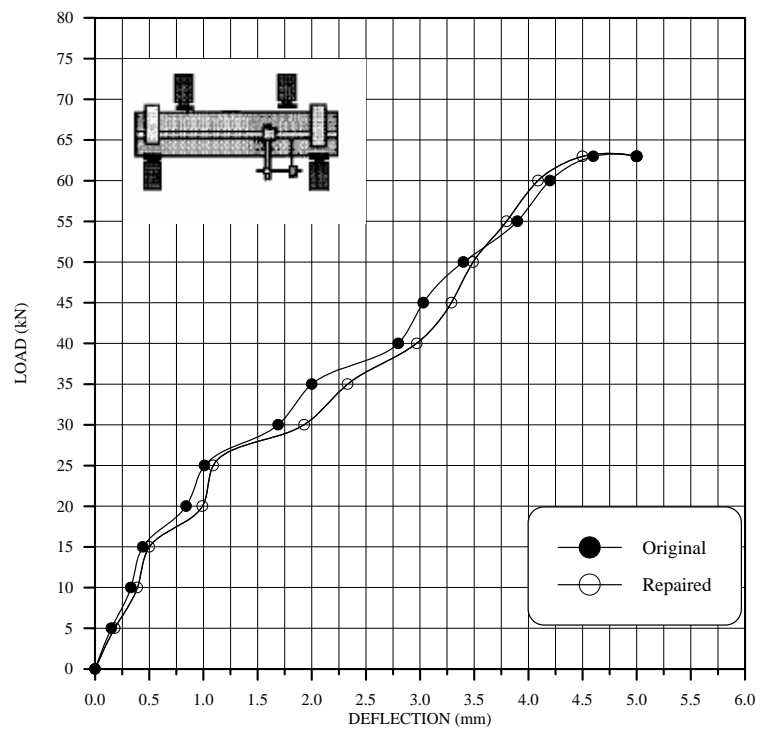
Figures (2), (3), (4), and (5), show the load deflection for beams (B_1 , B_2 , B_3 and B_4) at first third of beam span. **Figures (6), (7), (8), and (9)**, show the load deflection for beams (B_1 , B_2 , B_3 and B_4) at second third of beam span. **Figures (10), (11), (12), and (13)**, show the load deflection for beams (B_1 , B_2 , B_3 and B_4) at mid span of beam. It is obvious from the recorded data that the strength of the repaired beams was not softer than that of the original beams for high-strength concrete.

Figure (2) Load-deflection behavior at first third from the support of Beam B1

Figure (3) Load-deflection behavior at first third from the support of Beam B2

Figure (4) Load-deflection behavior at first third from the support of Beam B3

Figure (5) Load-deflection behavior at first third from the support of Beam B4

Comparison of the load-deflection curves indicates that the integrity of the beams was really restored by epoxy injection. The results show that the repaired high strength reinforced concrete beams exhibited greater flexural rigidity at high intensities of load.

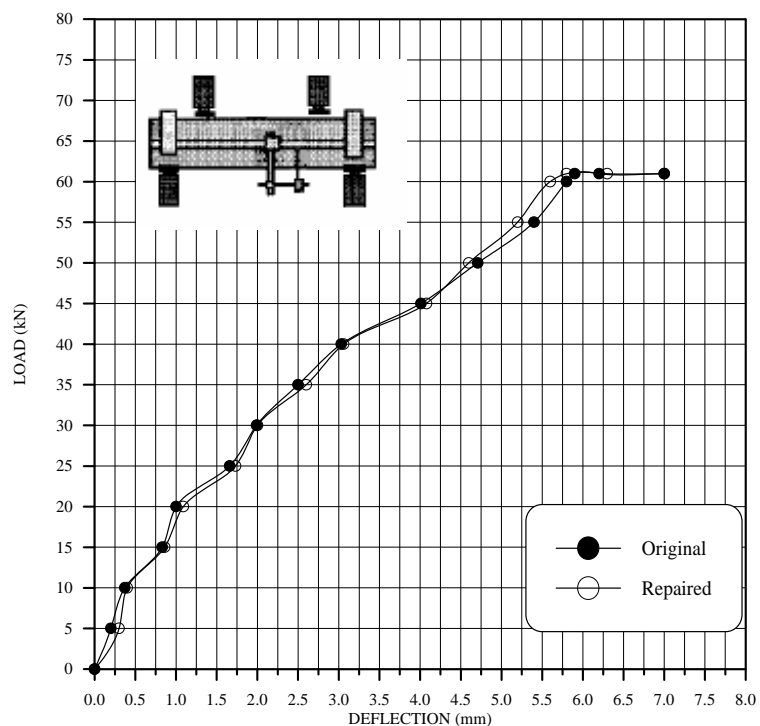
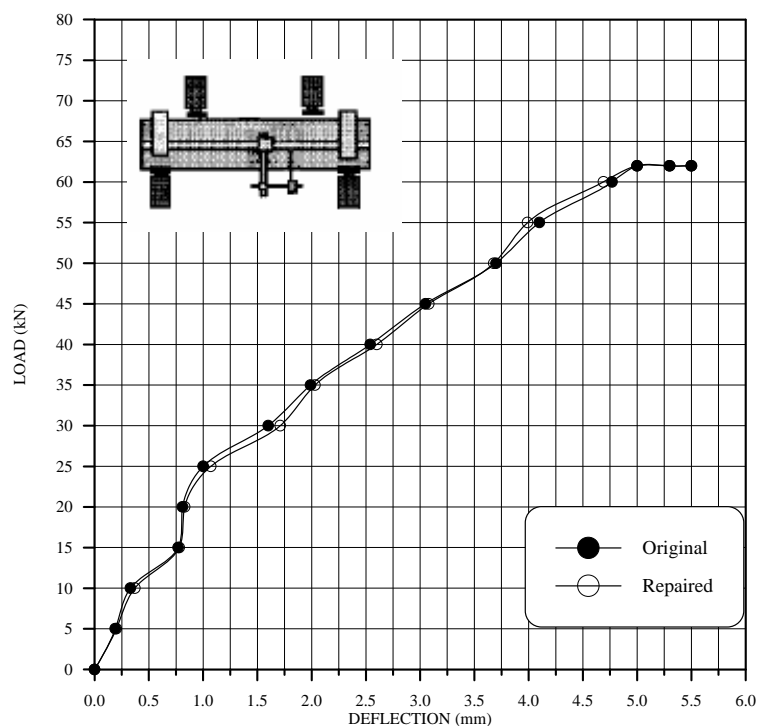
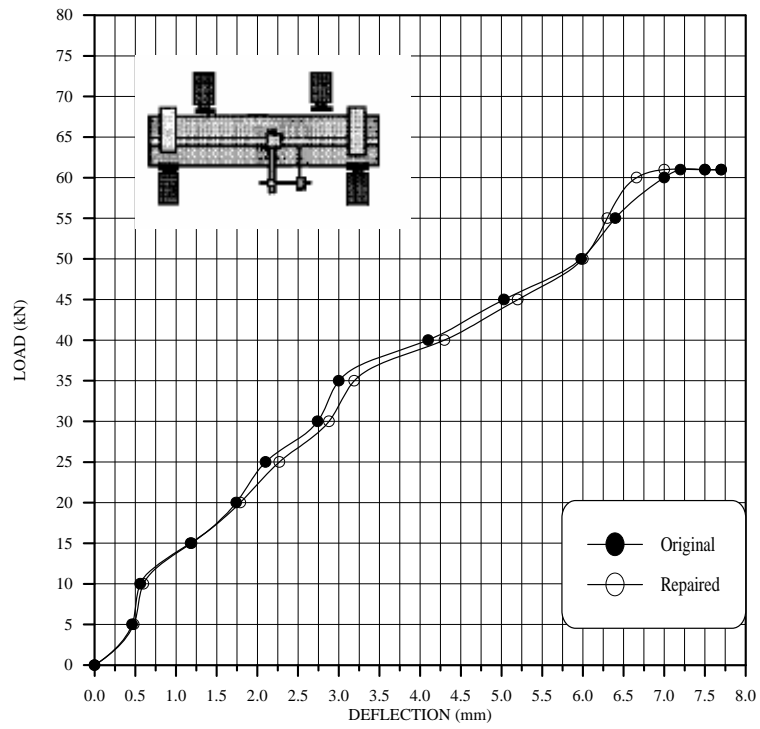
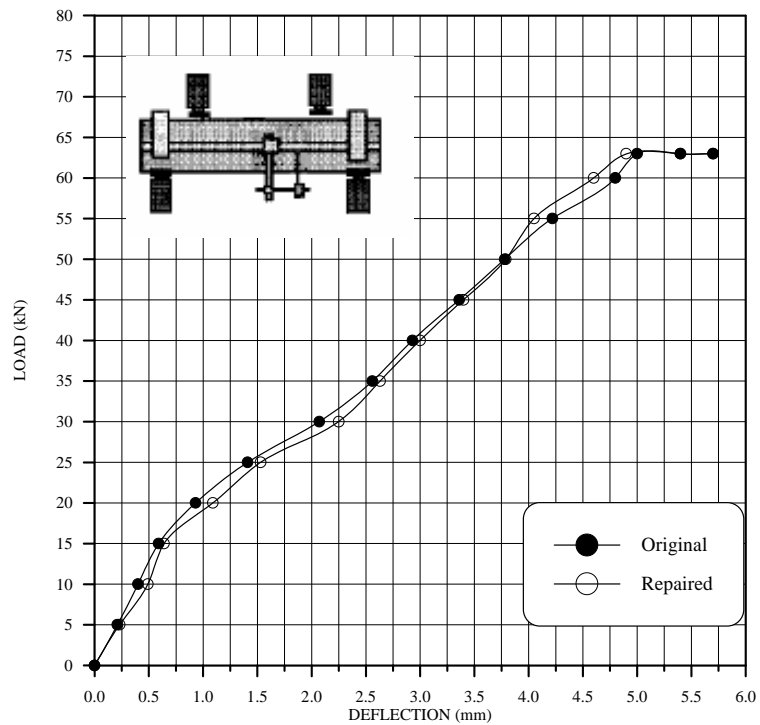
Figure (6) Load-deflection behavior at second third from the support of Beam B1

Figure (7) Load-deflection behavior at second third from the support of Beam B2

Figure (8) Load-deflection behavior at second third from the support of Beam B3

Figure (9) Load-deflection behavior at second third from the support of Beam B4

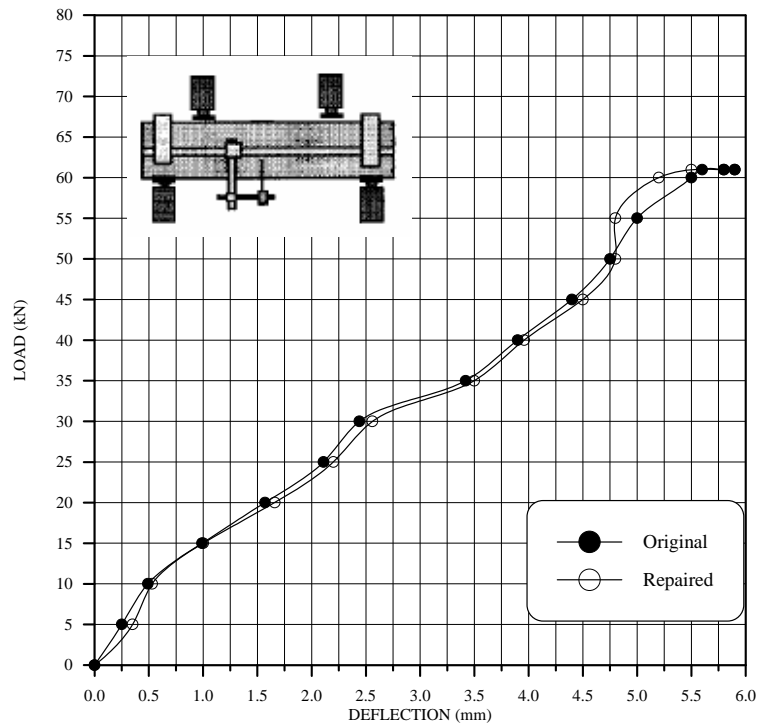
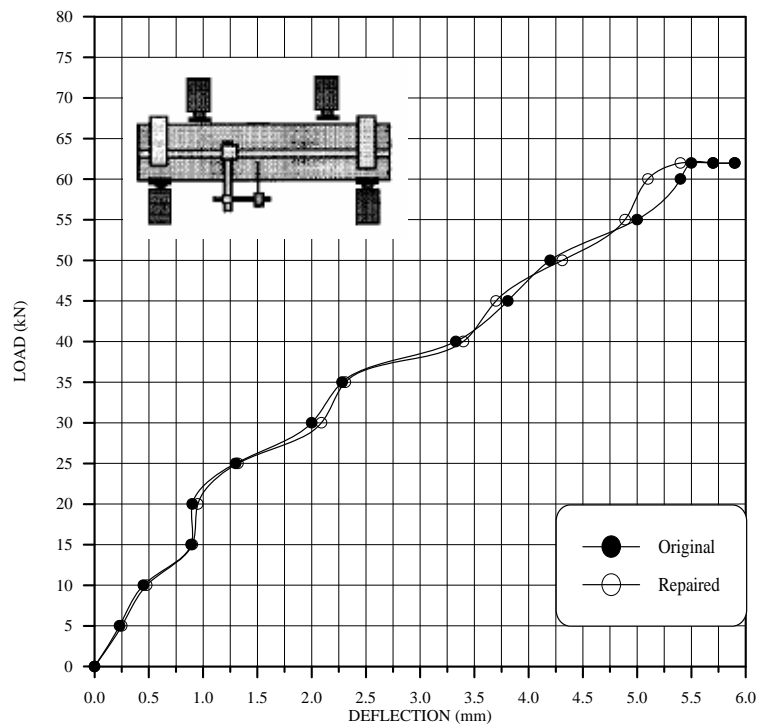
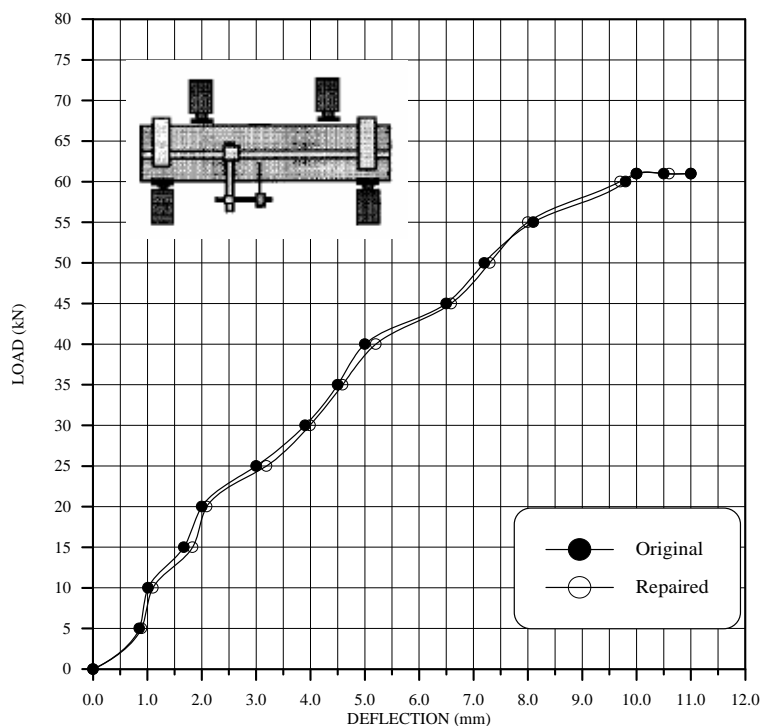
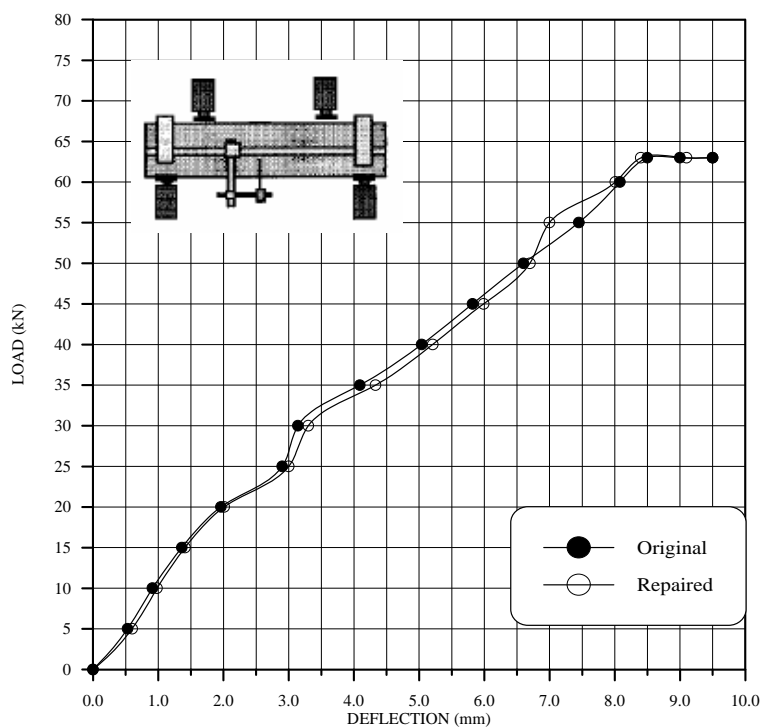
Figure (10) Load-deflection behavior at mid span of Beam B1

Figure (11) Load-deflection behavior at mid span of Beam B2

Figure (12) Load-deflection behavior at mid span of Beam B3

Figure (13) Load-deflection behavior at mid span of Beam B4
